Mi. 88.7 Ruel – Derailment March 7, 2015

**Mayerthorpe, Alberta  
Mile 74.7 Sangudo Subdivision  
Tuesday April 26, 2016**

# New Technology Projects

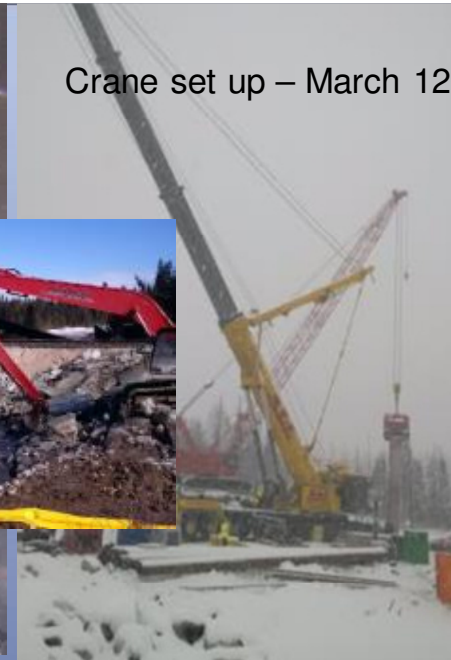
Crane set up – March 12

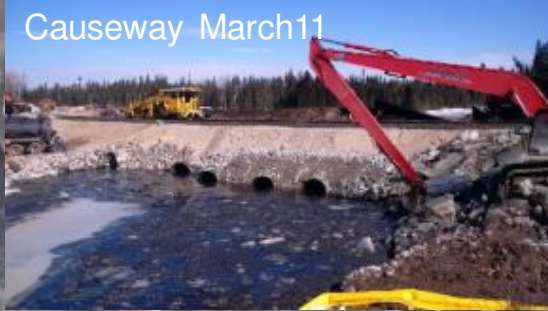
Causeway March 11

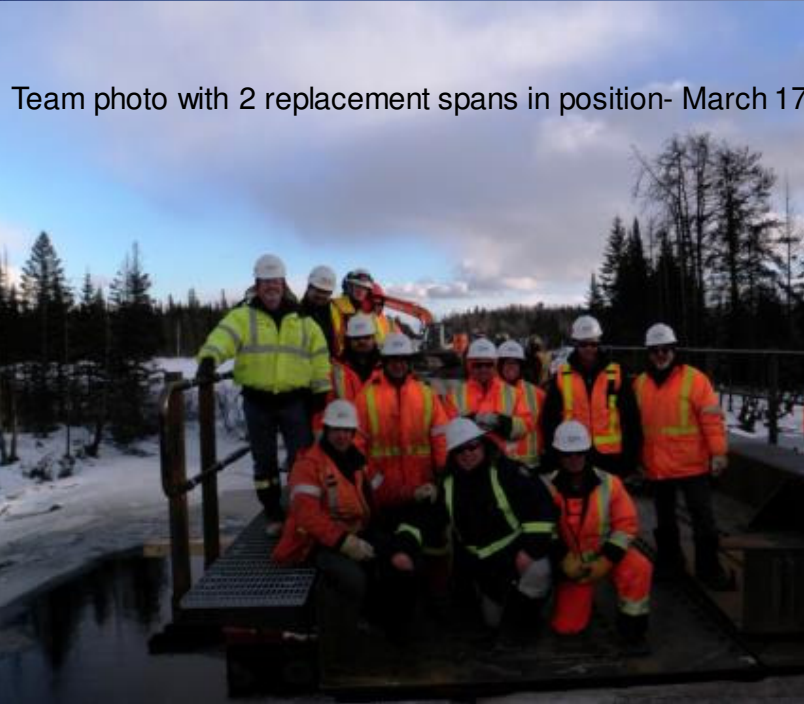
Single span 99' TPG destroyed

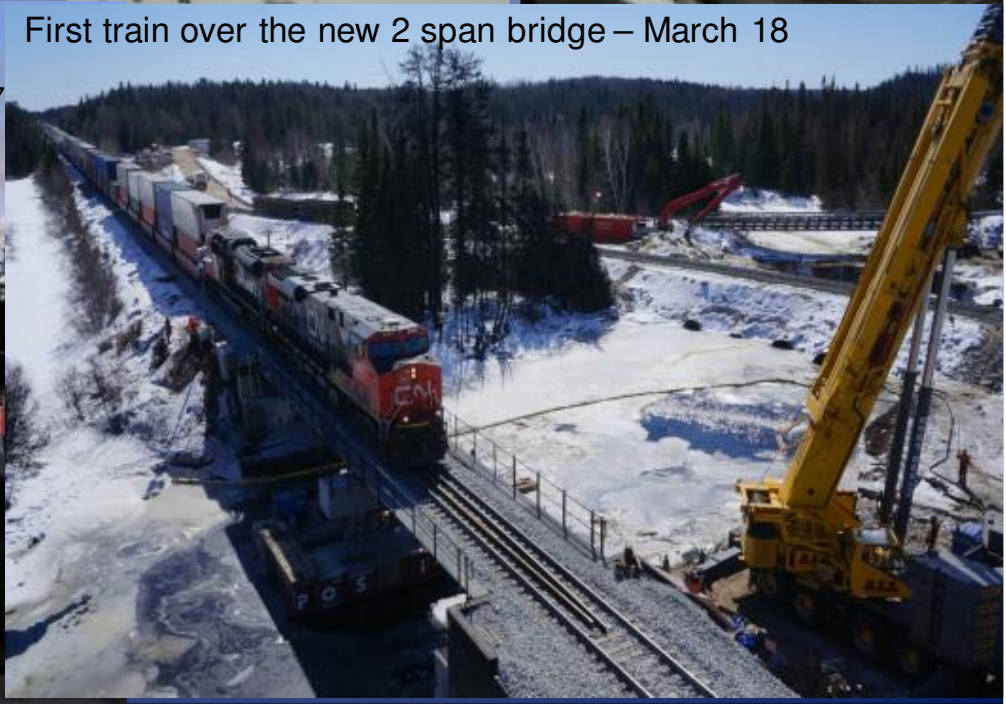
Team photo with 2 replacement spans in position- March 17

First train over the new 2 span bridge – March 18

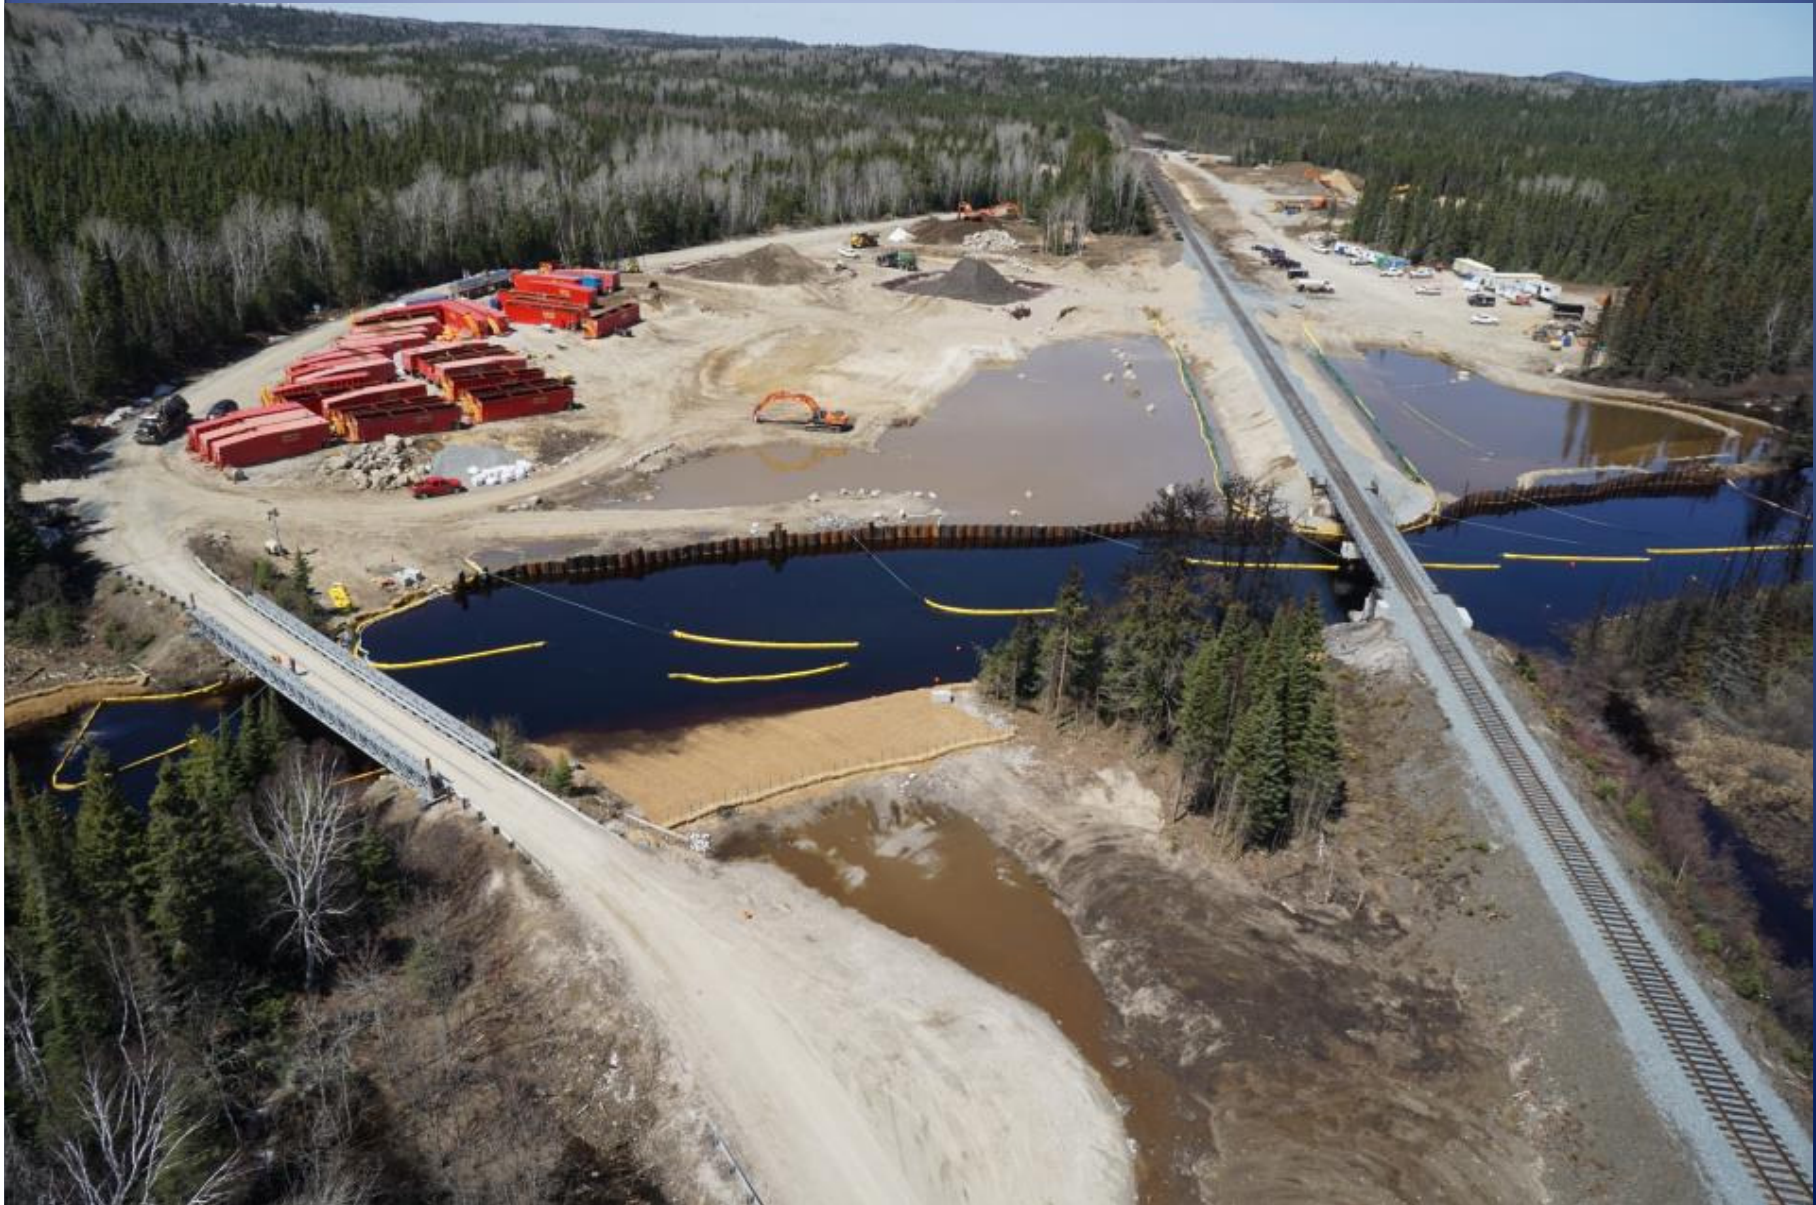
## Site environmental remediation – summer 2015

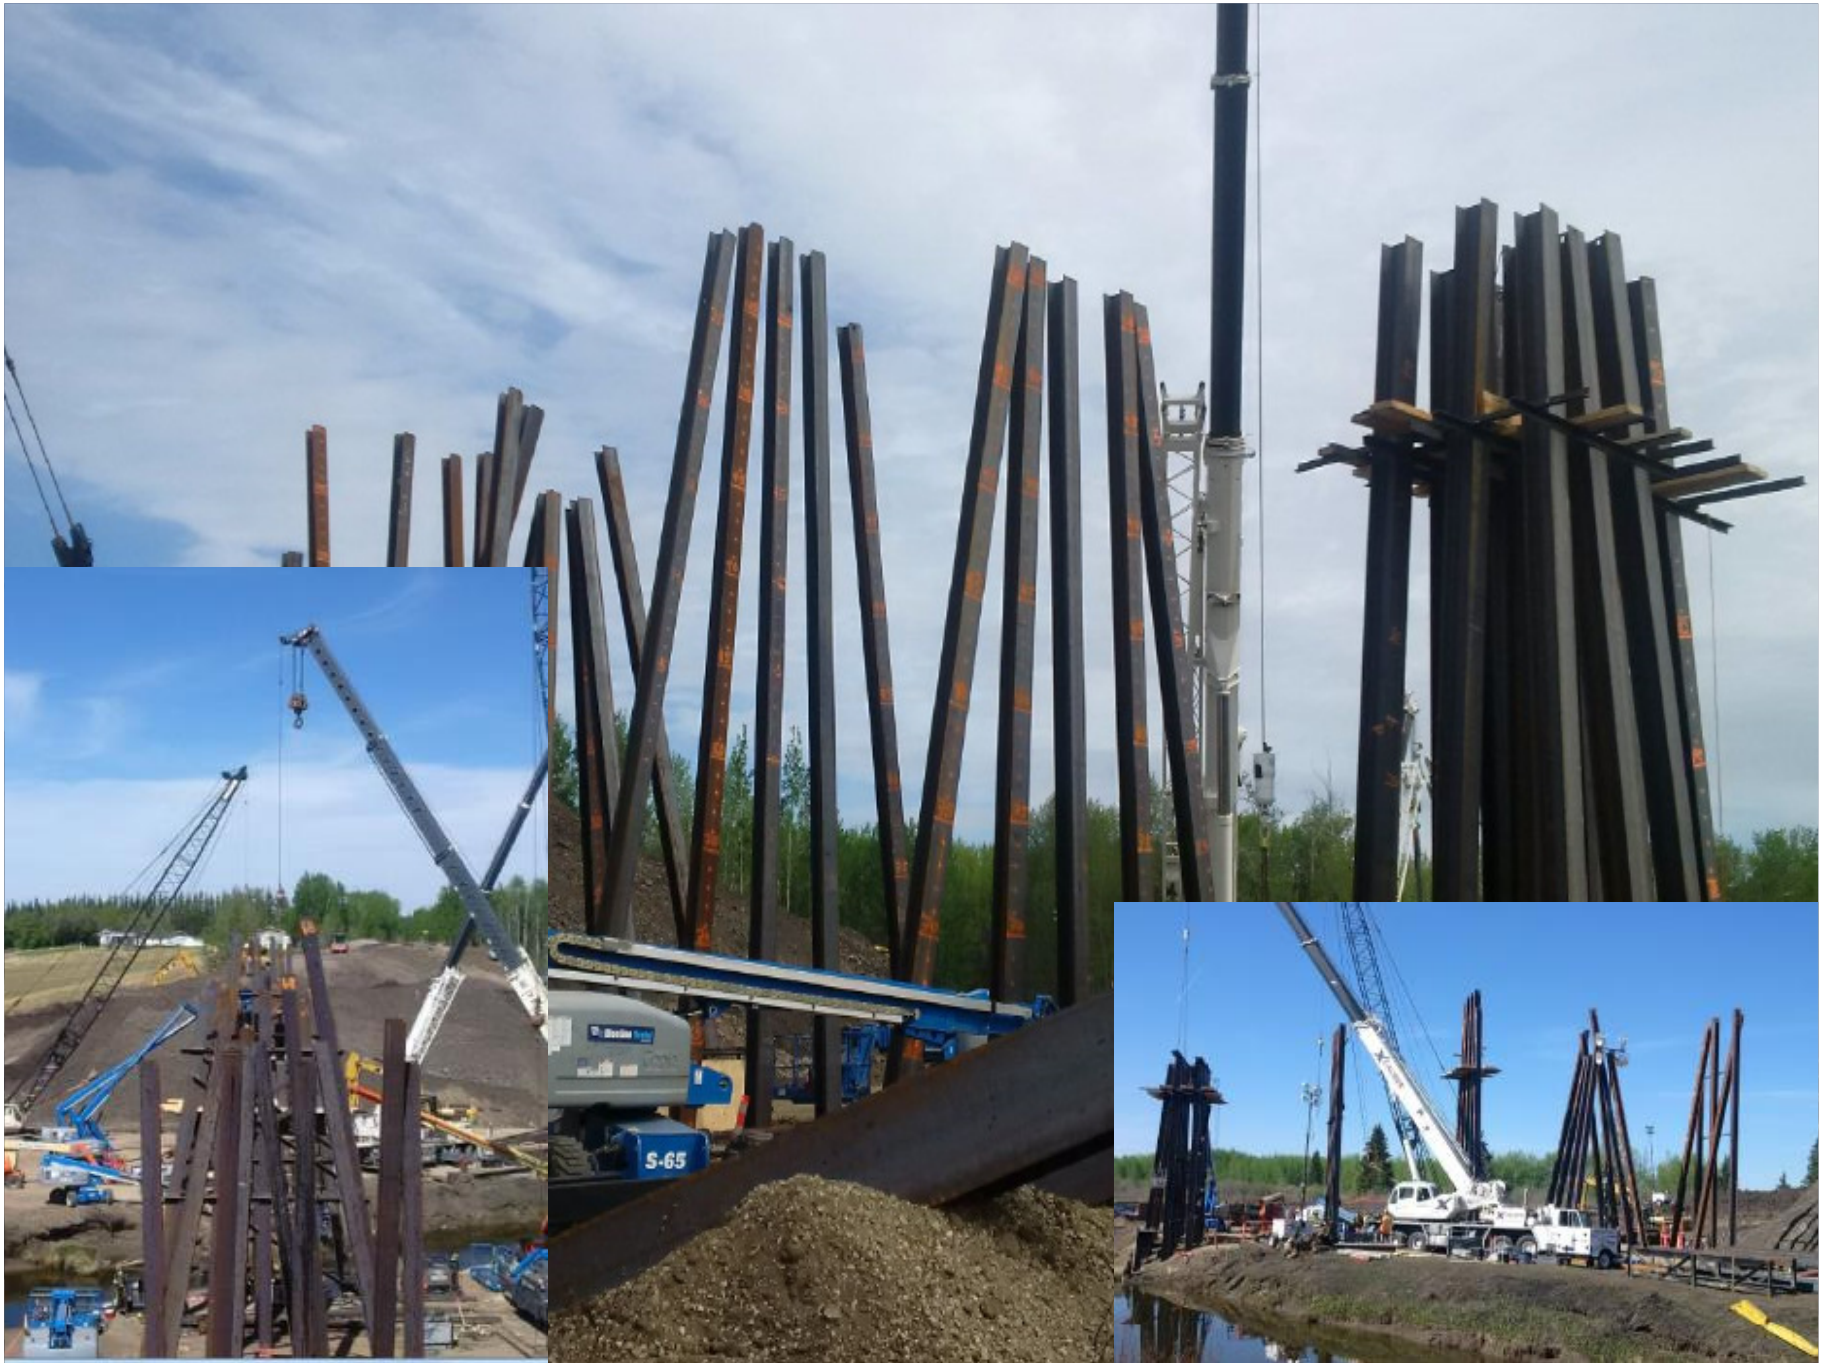
Updated schedule developed May 4<sup>th</sup> Identifying activities and timeline to in service for Sunday May 15, 2016

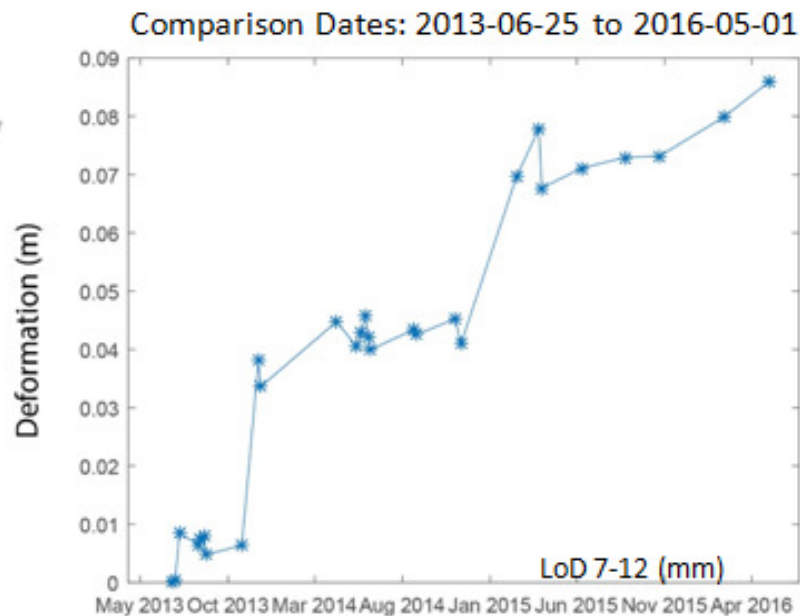
## Ashcroft Mile 94-94.6 (WCW Section 2)

- Approximately 400 m<sup>3</sup> potential volume
- Deforming since fall of 2013
- Continued deformation since February 13, 2016 (last update)

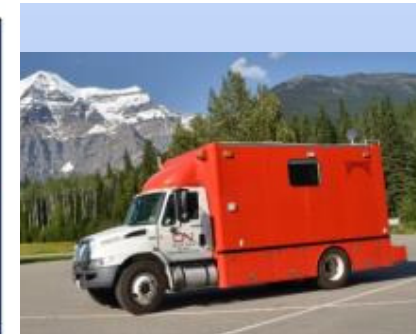
Frequency domain reflectometer

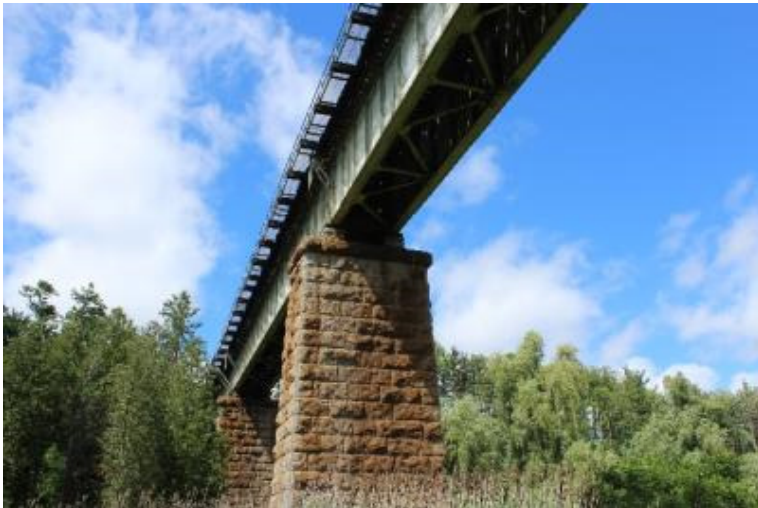
## Displacement Measurement by Radar - Case study: 26.36 Halton

- Displacement measurement by radar technology does not require a fixed reference point immediately next to the point of interest.
- Displacements are derived from the minute changes in distance between the transmitter and targets.

- 600' long viaduct, 57' tall piers, 6-100' DPGs.

- Moderate lateral movement was reported at this location. The tall slender piers were suspected as a possible source.
- In order to assess the situation, measurements of the actual displacements of the piers and spans are needed.
- Since traditional measurement using displacement transducers is not feasible at this location due to the height, this offered a good opportunity to evaluate the DIC technology.

***Findings – perceived lateral movement originated at the tall pedestals not as a result of pier movement***
