# Track and Substructure Diagnosis

James Hyslip

**LTK** Engineering Services

20<sup>th</sup> International Convention of the Working Committee on Railway  
Technology (Infrastructure)  
Salzburg, Austria

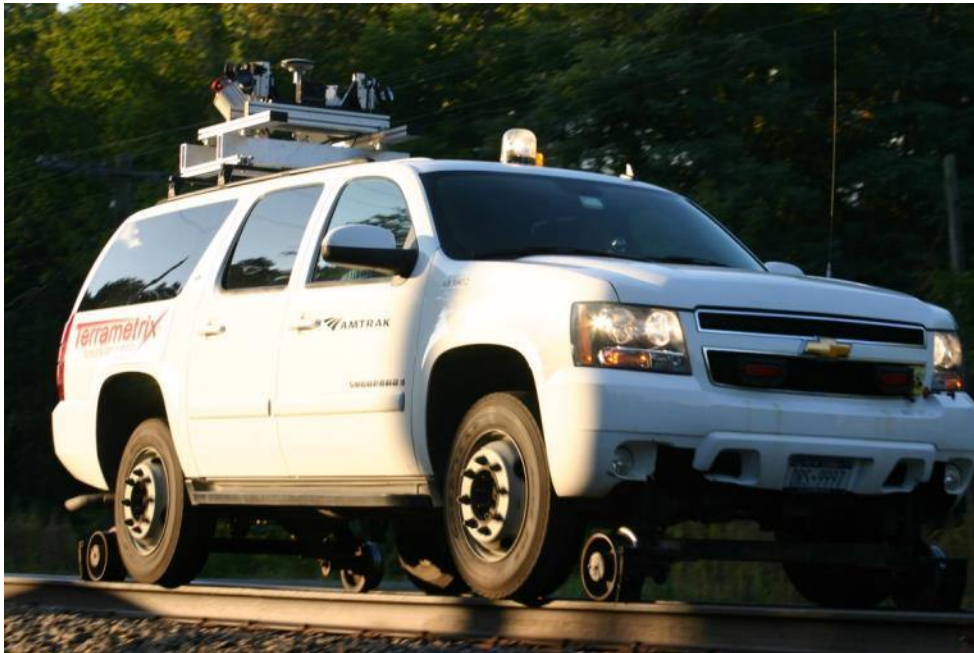
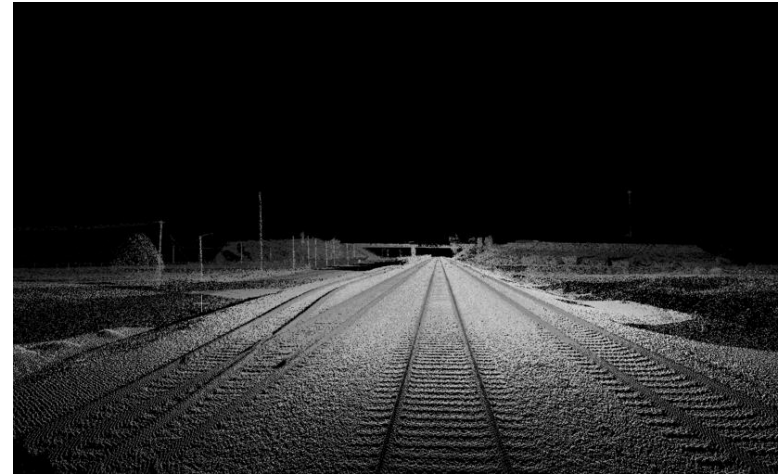
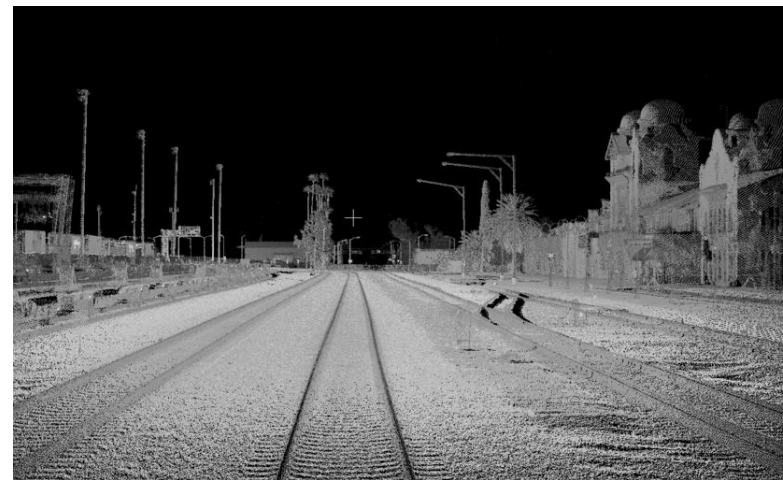
# Ground Lidar Mapping

**Terrametrix**<sup>TM</sup>  
terrestrial lidar in motion

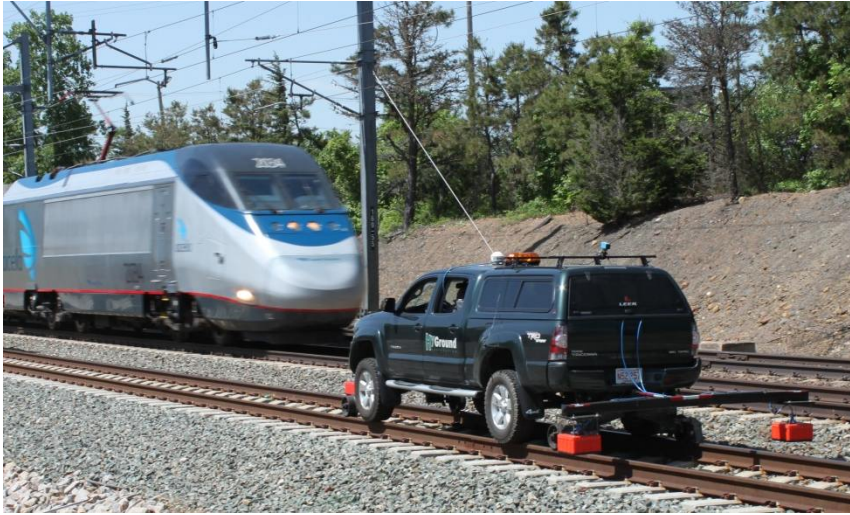
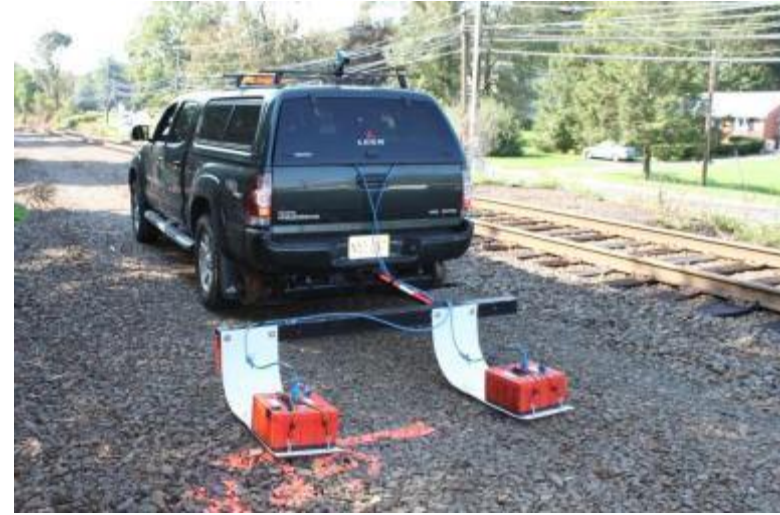
# Ground Penetrating Radar (GPR)

- ***Layers***
- ***Moisture***
- ***Fouling***

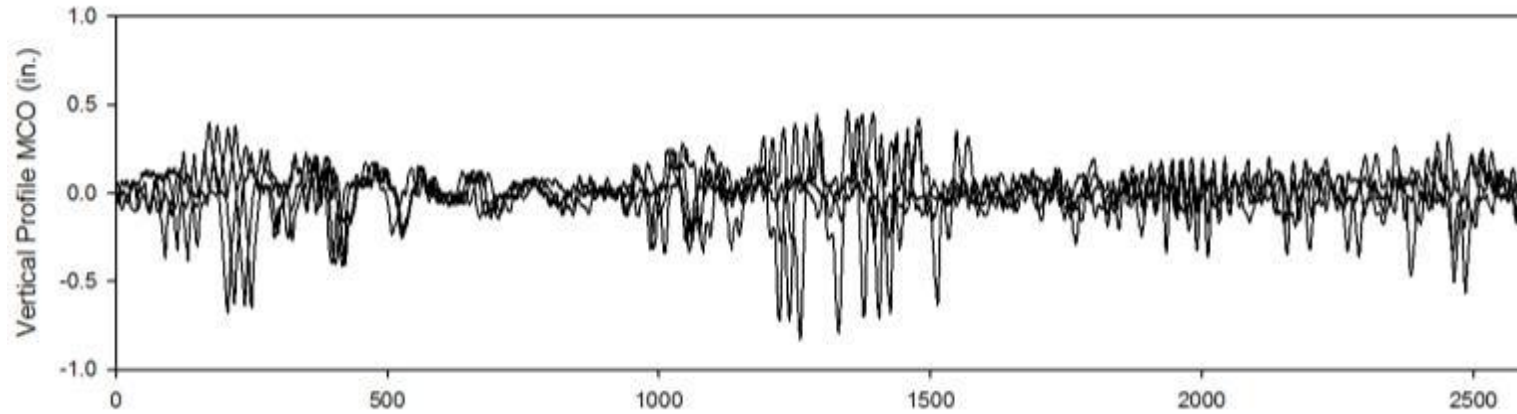
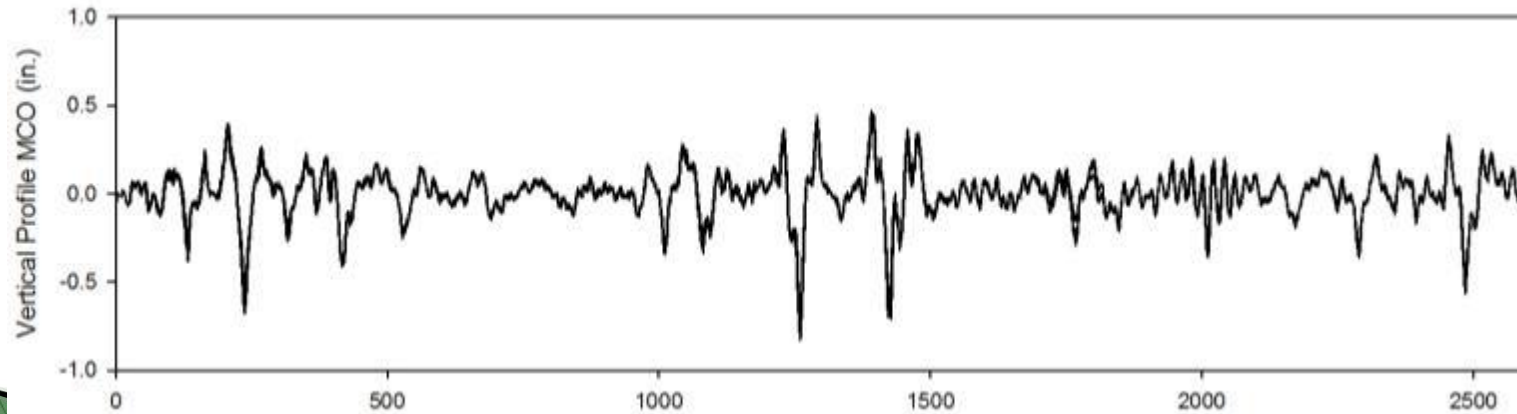
# Track Geometry

## Measured

## Aligned

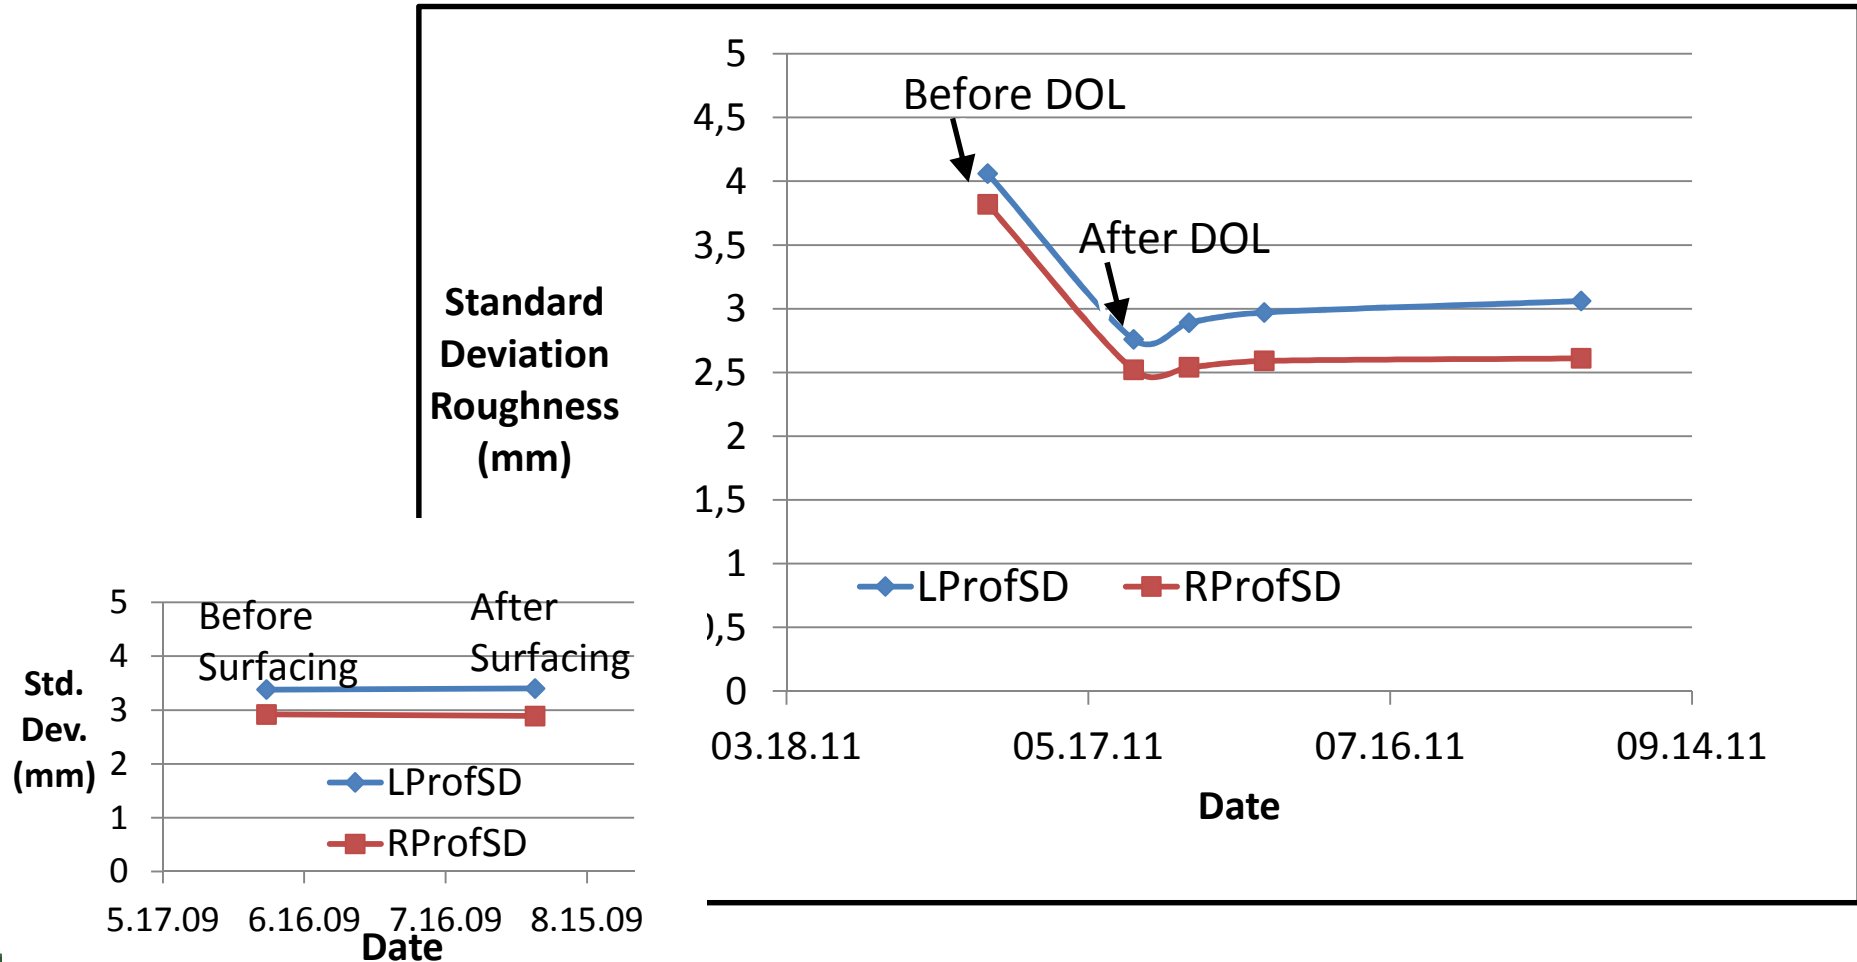
# Design Over Lift (DOL) Tamping

DOL found to be at least 3X more durable than conventional tamping under Passenger and HAL Freight traffic

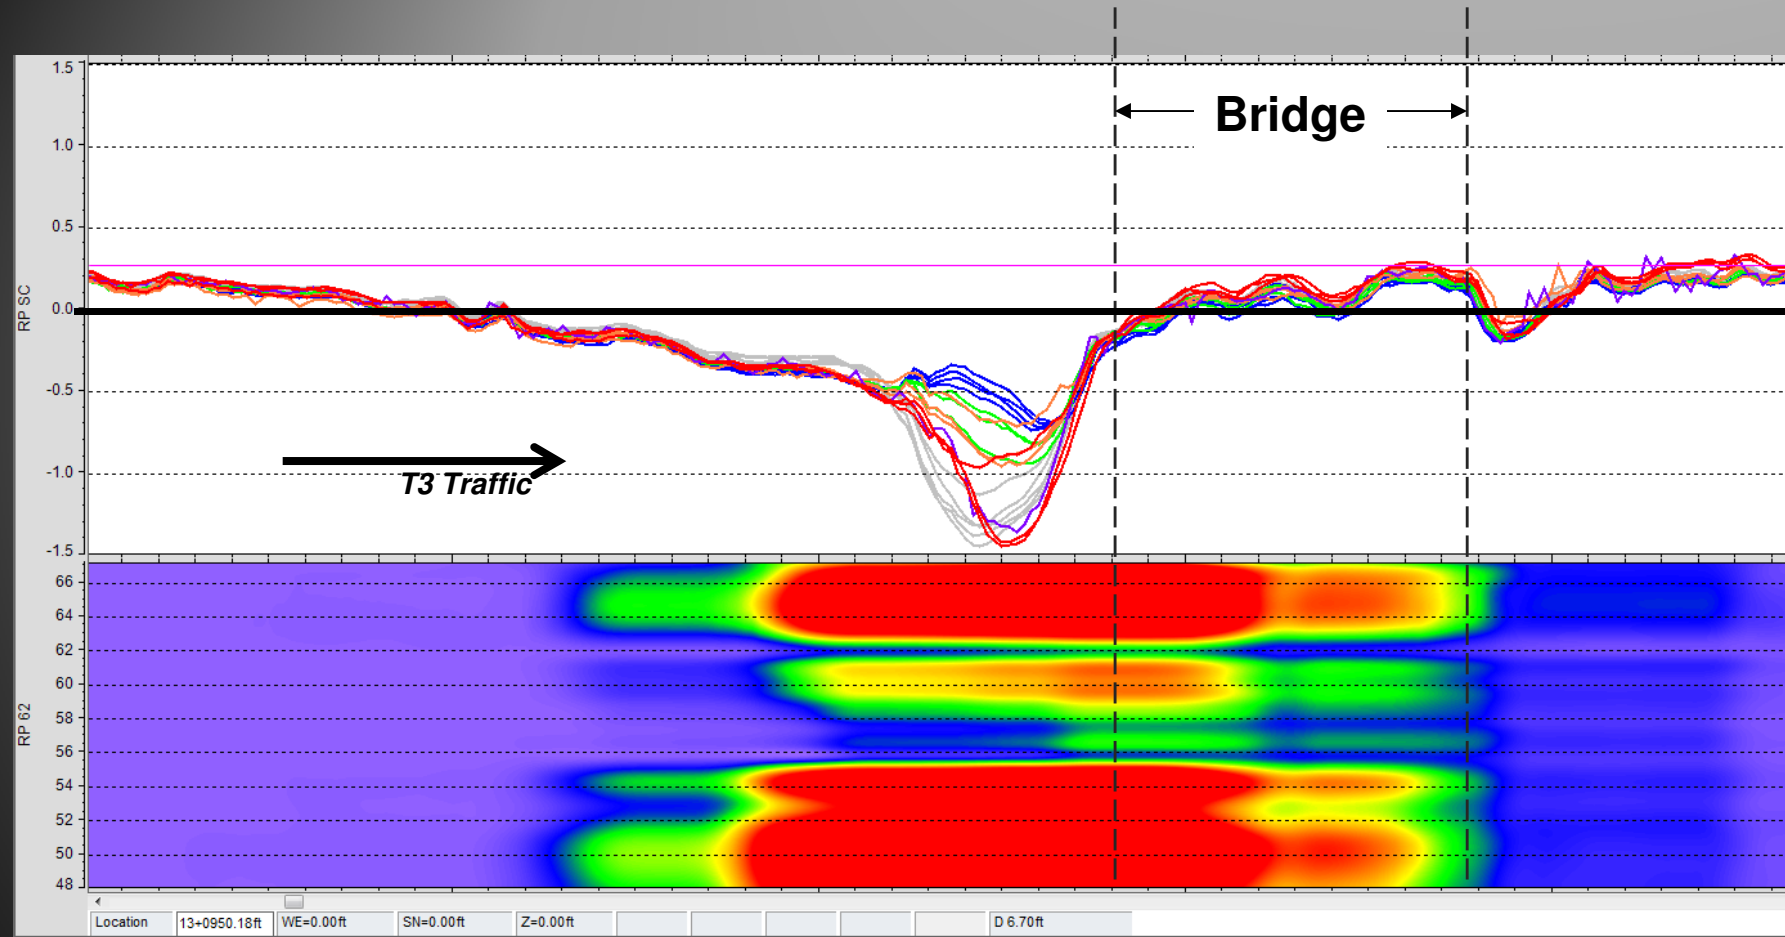
# Transition Improvement - Chemical Grouting

Chemical Grouting  
performed on 7/18/14
